*** NEW TYPE RELAYS ***

One of the main problems with the FT 102 is intermittent receive, due to faulty relays on the R.F. Board. There has been many suggestions of treatment such as 'sell it quick !' or 'hit it with a sledge hammer'.

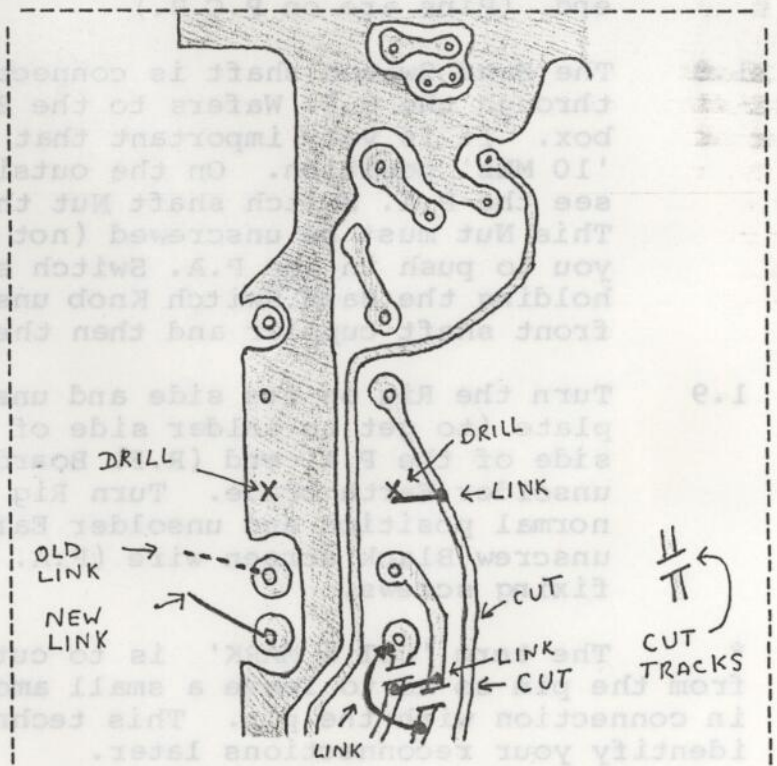
- The Relay coil pins are located in a different position so drill two 1.5 mill holes into the P.C.B. at positions x on diagram (Figure 1).
- The N.C. contacts on the old relay are the N.O. contacts on the new Relay and so you will have to cut P.C.B. tracks and make links as shown on diagram (Figure 1) and then fit new Relay.
- Check all connections to diagram (Figure 1).

- 2.0 Lay your R.F. Board on clean work-bench, unscrew the 2 cross point screws at front section of wafer to release bakelite strip and release circlip on shaft. Locate RL05 24 V. Relay, unsolder and fit (FM92A). Locate RL04 24 V. Relay, unsolder and fit (FM92A). Locate RL03 12 V. Relay, unsolder and fit (FM94C).
- 2.1 Locate RL01, unsolder and fit new part (FM94C) and note new type Relay has not got dummy pin in same position so will require a wire link jumper to be fitted.
- 2.2 Locate RL02 and unsolder. Note the new (YX95D) Relay is not of the same pinning. Refer to Notes a to c and Figure 1 below and make the following mods to the P.C.B.
